CAMDEN HISTORIC LANDMARKS COMMISSION

AGENDA

BAILEY BILL HISTORIC PROPERTY REHABILITATION APPLICATION

HISTORIC PRESERVATION CERTIFICATION APPLICATION
PART 2 – DESCRIPTION OF REHABILITATION

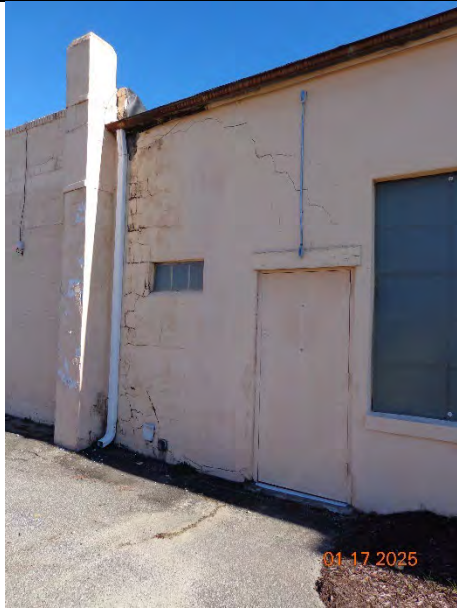
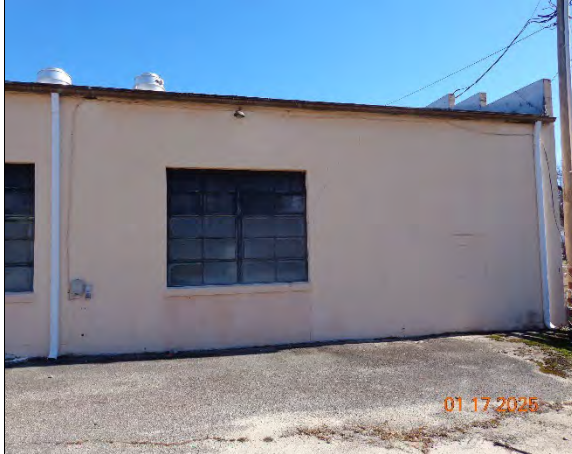
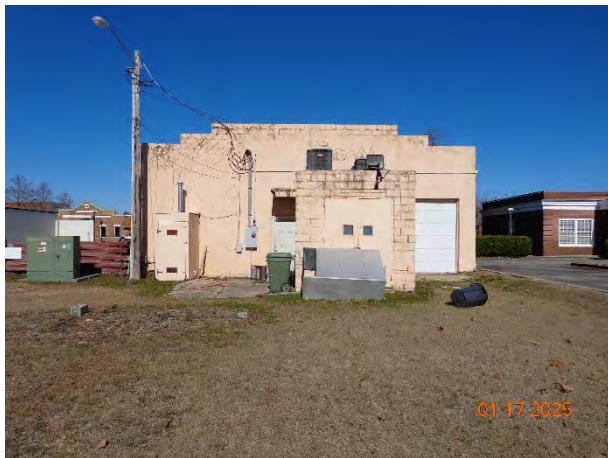
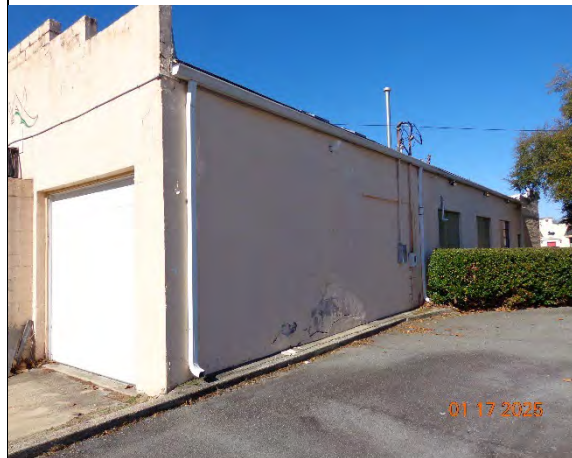
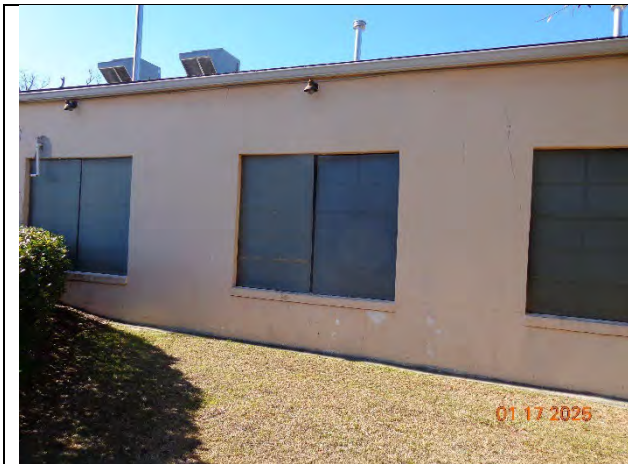
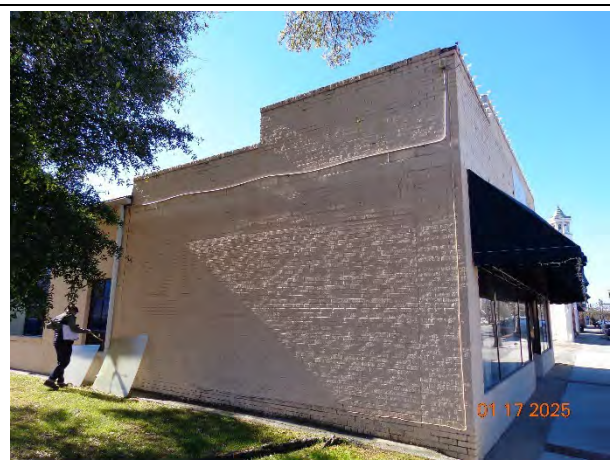
Exterior walls comprised of brick, brick covered with stucco, and concrete block covered with stucco. The exposed brick is painted and in good shape. The stucco coating over the brick is cracked or missing from areas. Existing exposed concrete block has signs of cracked grout joint line and water penetration into building.

Existing exterior walls to be cleaned, loose material removed and replaced with similar previous material. Areas of water penetration to be sealed. Entire building to be repainted.

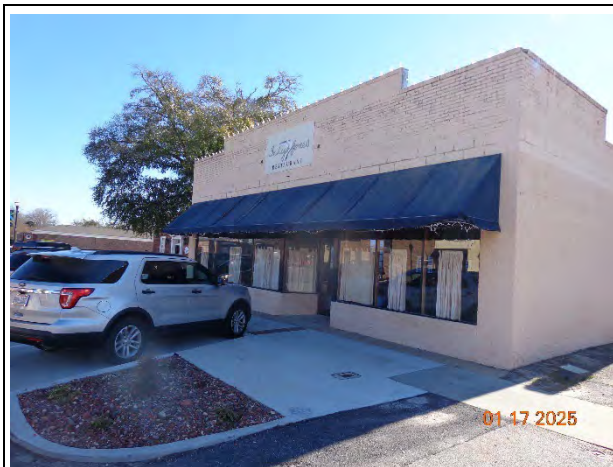
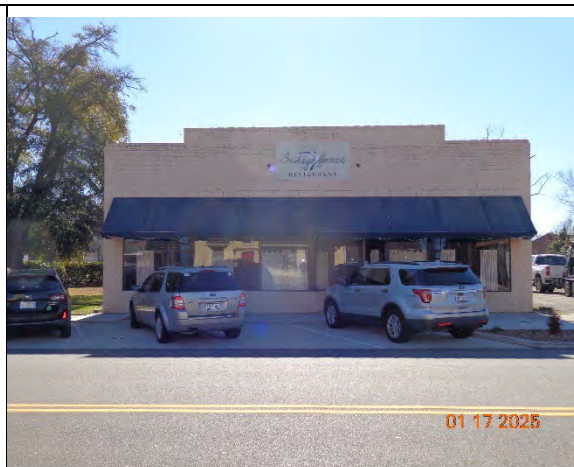
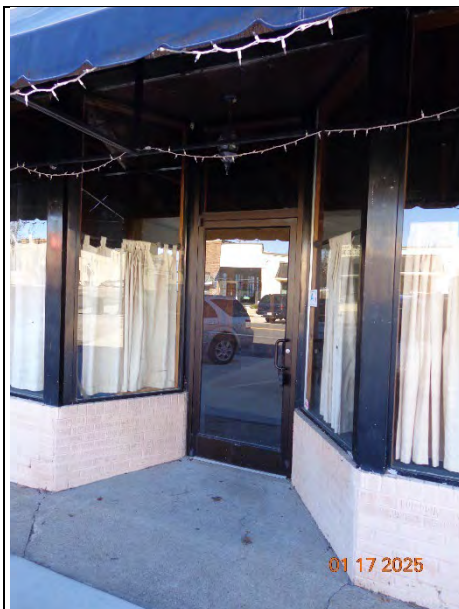
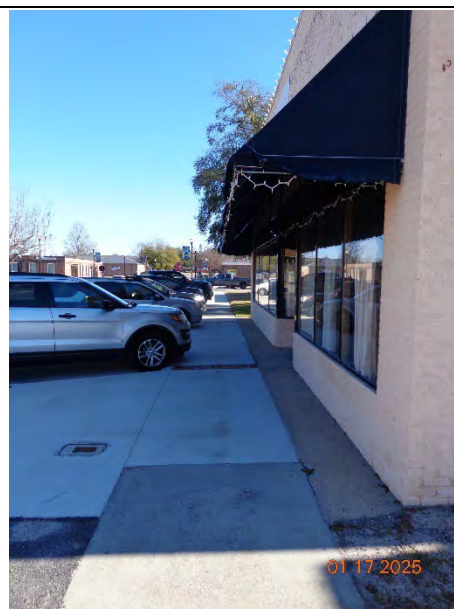
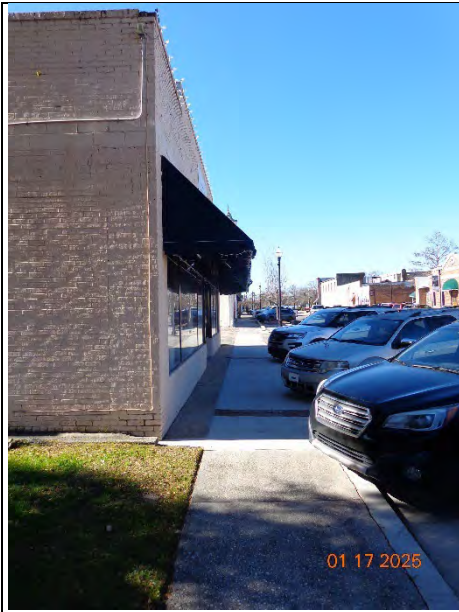
Existing storefront and awning is in good shape.

Storefront to be cleaned and front door operation to be worked on.
Awning fabric will be replaced with new.

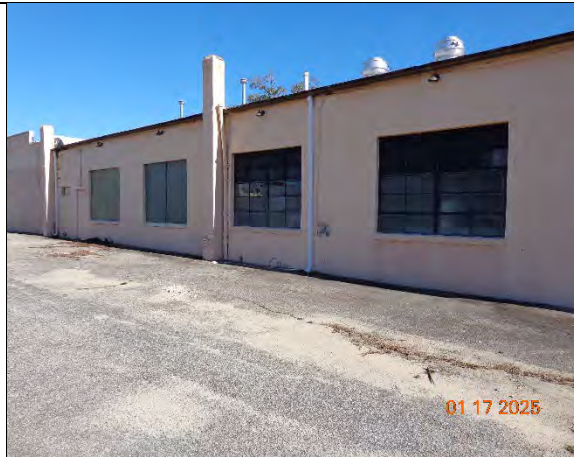
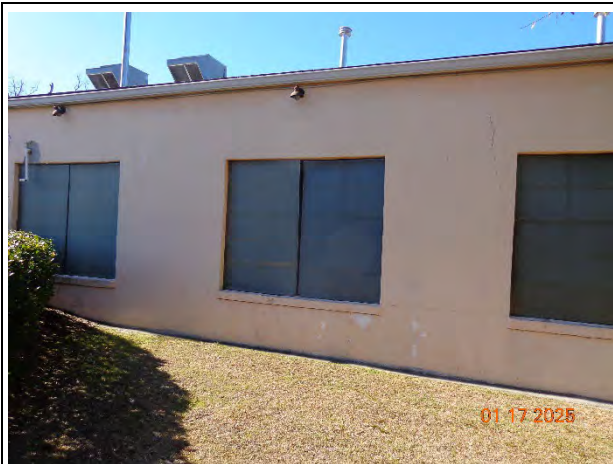
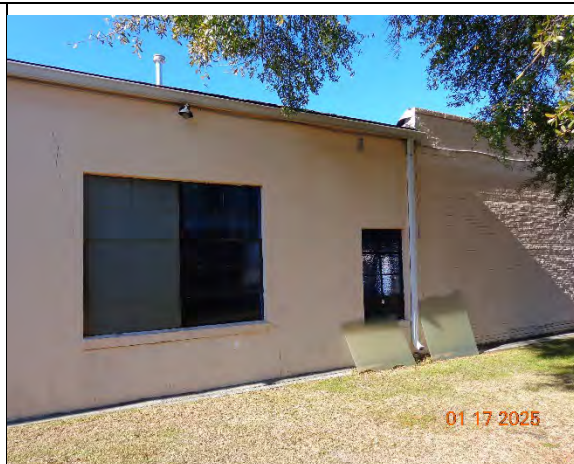
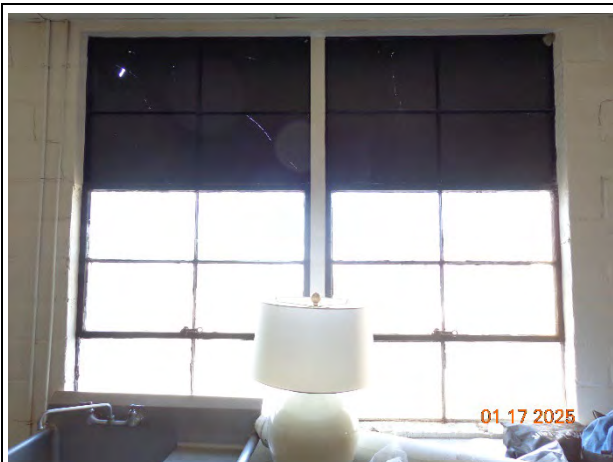
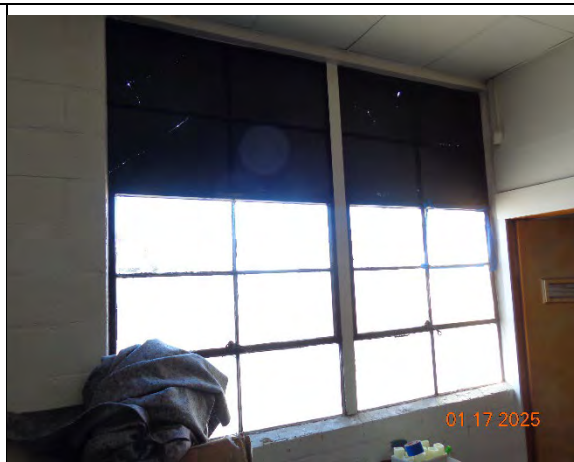
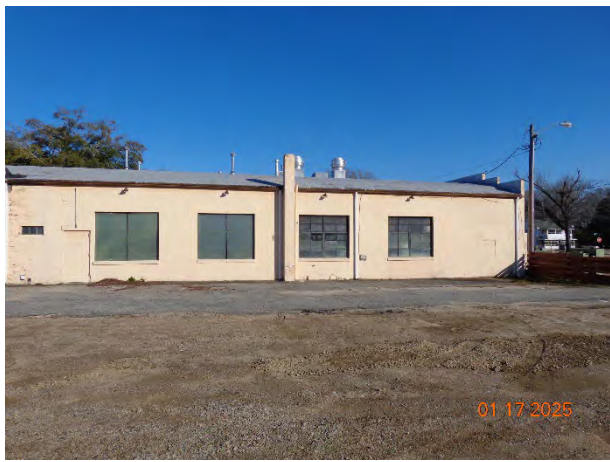
Exterior windows appear to be original single pane glass set in metal grid frame. Lower panels opens to the outside and are secured when closed with a handle latch. Some of the openings are covered with an opaque plastic panel.

Existing opaque panels are to be removed from all openings. Missing glass will be replaced with similar glass panels and frames will be refurbished, cleaned up, and new caulk/sealant around glass panels.

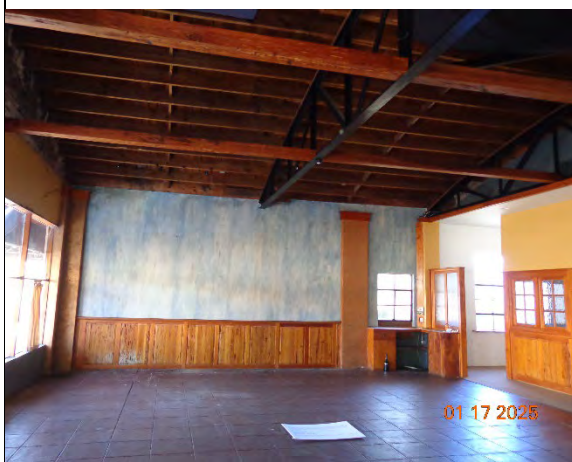
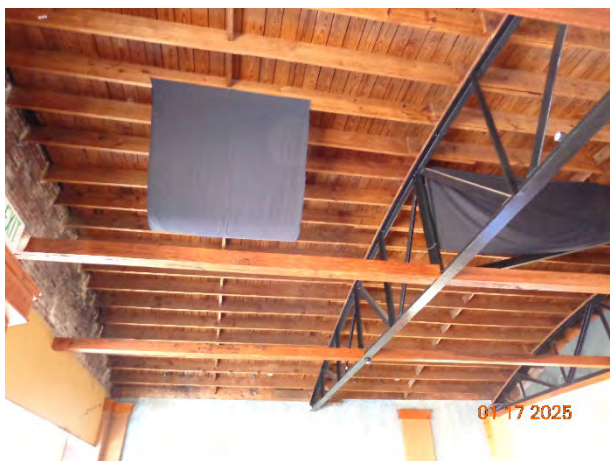
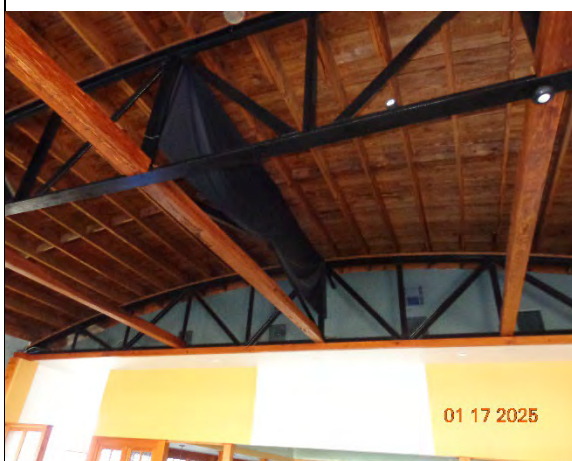
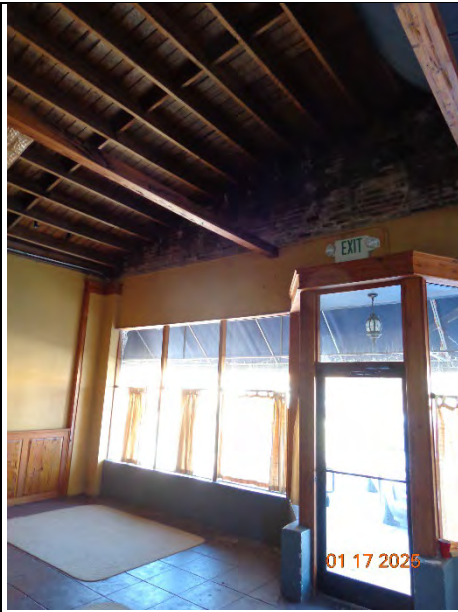
Interior of building has been used as previous restaurants for the past several years. Front half of the interior space is set-up for the public dining area and the back half is set-up as the kitchen, storage, and dish-washing area. Overall condition of this area is generally good. Half of the front area consists of original exposed concrete floor, exposed ceiling with original barrel roof steel truss system, wood trusses, and wood 1X decking. The other half of the front area consists of glue-down carpet, lower drywall soffit and ceiling, and wood panel walls with glass panels.

The new scope of work is to remove all wall finishes, all flooring down to the existing concrete, all countertops and bar area, all drywall soffit and ceiling, all existing furnishes. The intent is to open the entire ceiling back to original conditions of the building to expose the steel barrel trusses and wood joists. Along with exposing the concrete floor so it can be rehabilitated. The new work will be to revitalize the original ceiling and floor to be uniform throughout the front dining area. Install a new side door. Install a new private dining room, new bar, and new built in booths for dining. Remodeling and refurbishing of the three existing restrooms will also be completed during this phase.

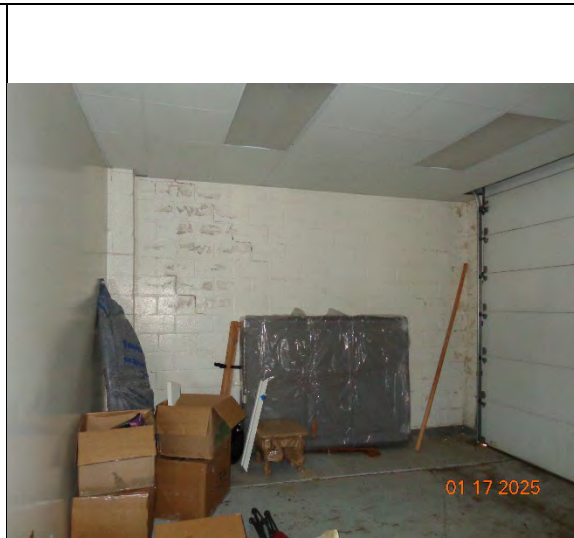
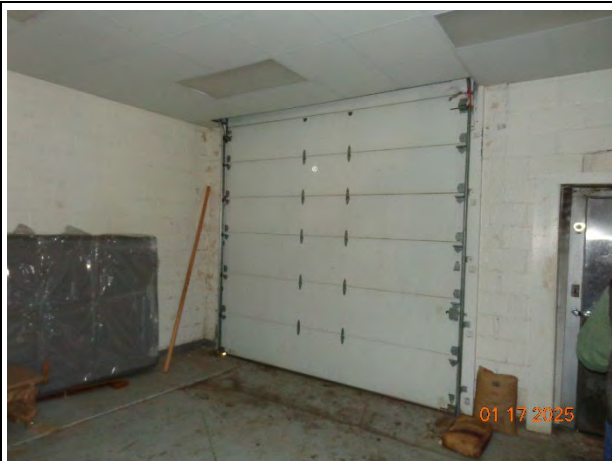
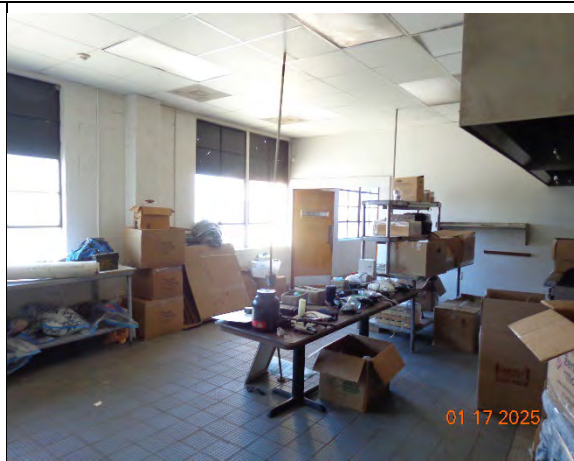
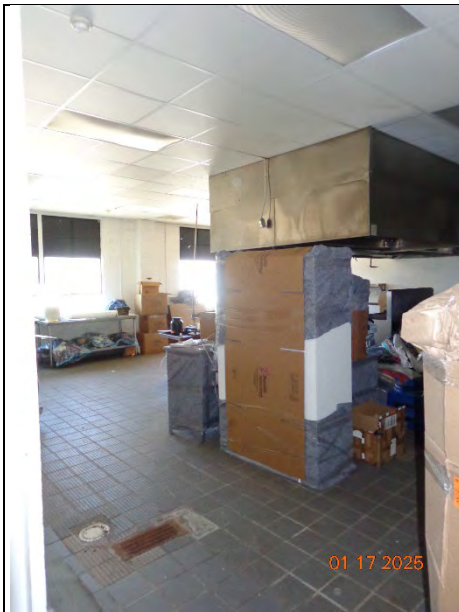
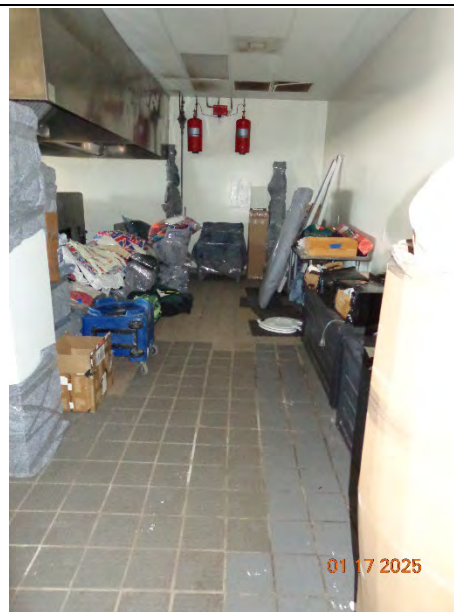
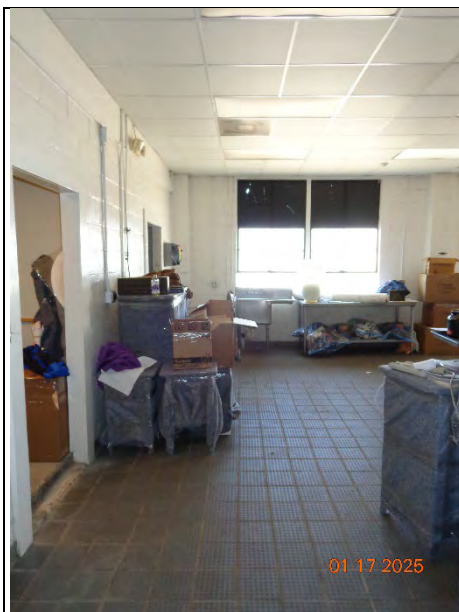
Interior of building has been used as a previous restaurant for the past several years. The back half of the space is set-up as the kitchen, storage and dish-washing area. Overall condition is generally good.

All existing kitchen equipment (except hood system) is to be removed and replaced with new. Existing ceiling to be removed and replaced with new. All HVAC and electrical items above ceiling to be removed. Walls to be cleaned and upgraded with proper wall finishes per code requirements. Floors to be deep cleaned and damaged quarry tile to be replaced. Existing rear door to be removed and replaced with new unit, along with rear landing. Existing roll-up door unit to be removed and new architectural window unit to be installed with pick-up window. Existing interior grease tank to be removed and replaced with larger unit on the exterior.

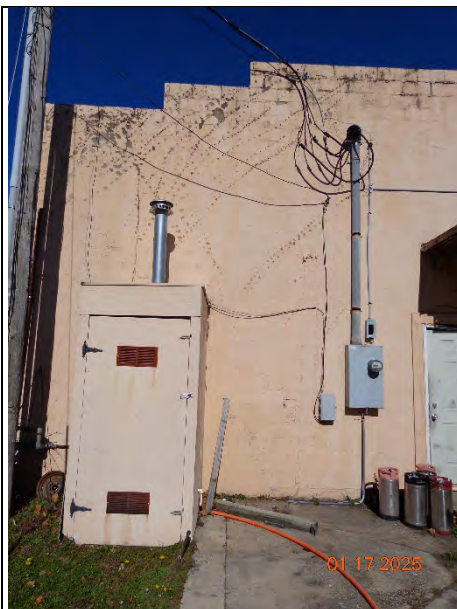
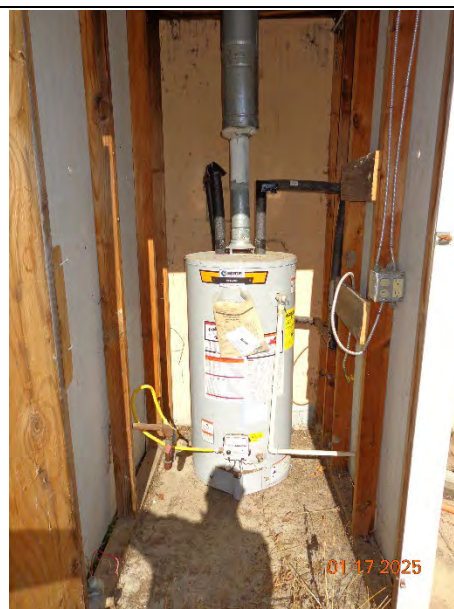
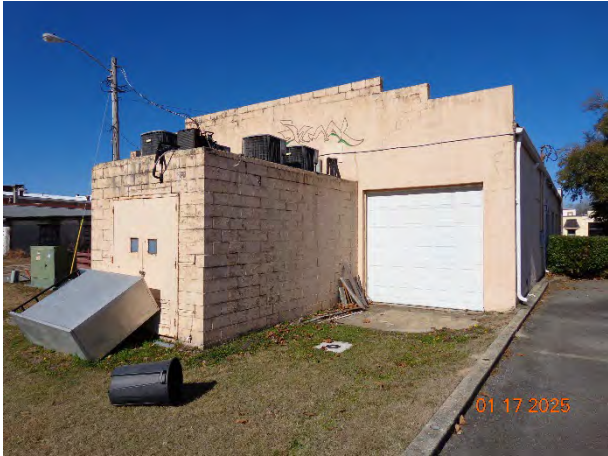
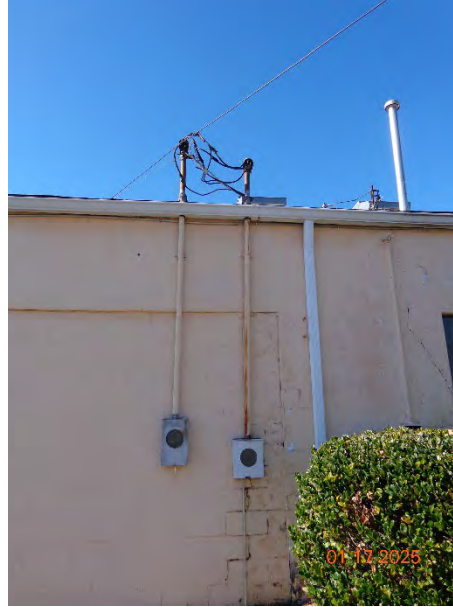
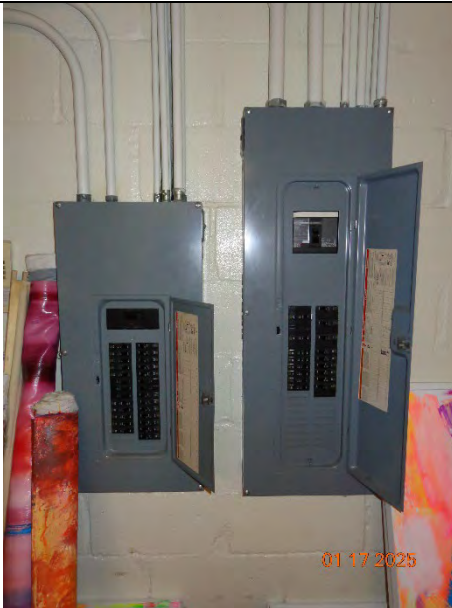
Existing HVAC, plumbing and electrical services for entire building are 20+ years old. Conditions of existing services are poor.

All existing HVAC equipment to be removed and replaced with new equipment and duct work. Plumbing water service to be upgraded and up-sized to accommodate new building service. This includes a new increased in size water line and a new grease interceptor. Existing electrical service to be upgraded and increased to handle the new equipment. Exterior abandoned electrical meter boxes, conduit and wire to be removed. Exterior water heater room to be removed and replaced with room similar in size for new hot water heater.
